# Manhole Inspection Summary

Manhole # S37U\_\_017MH

**Location** Address: **410 E.Randall St. (in back alley)**

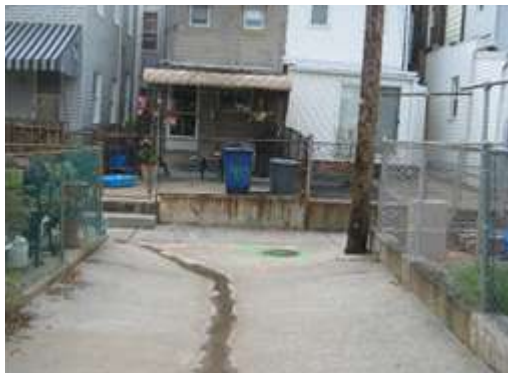
Location View

View facing south

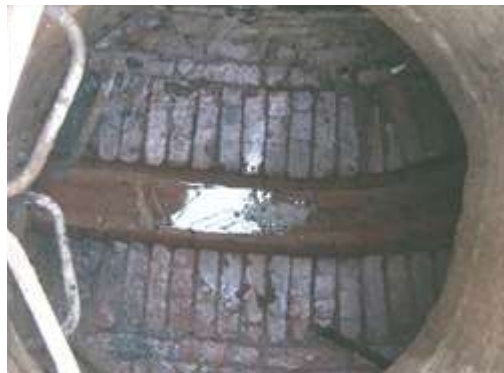
Top View

Comments **12:00 and 6:00 are not in top view because of MH configuration; frame is set on corbel**

Flow from 9:00 toward 12:00

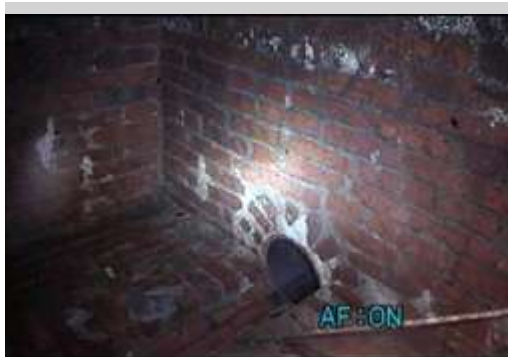
view of connection@6

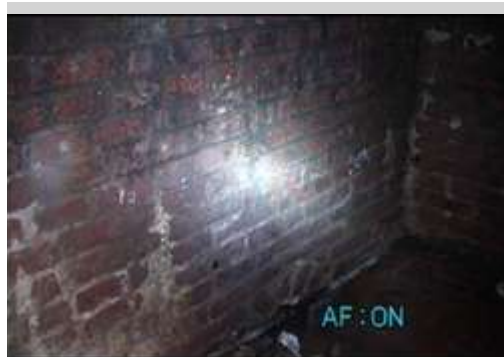
view of connection@12

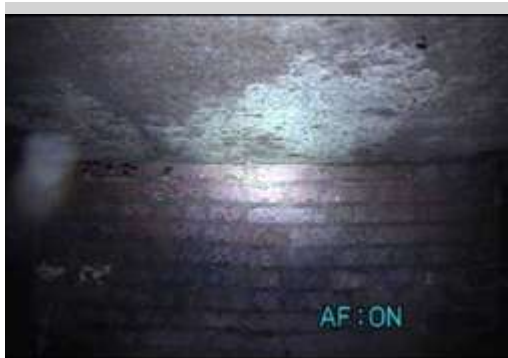
view of interior roof of structure

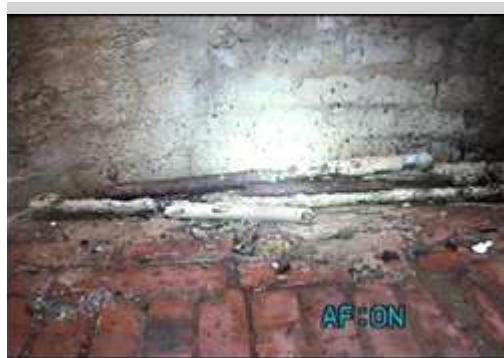
debris on the bench

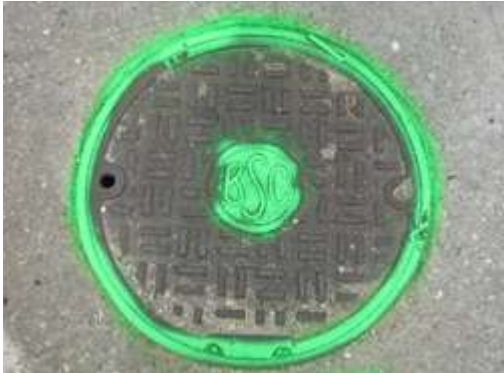
Condition: **Sound**

MH Lid

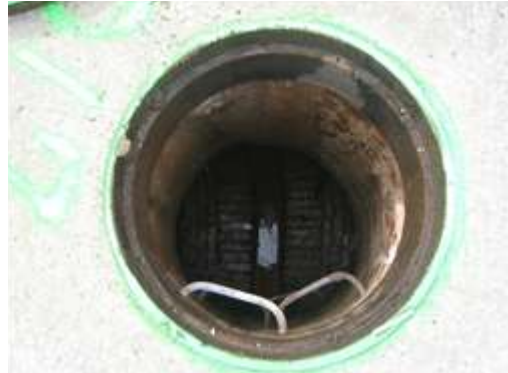
Condition: ☒ Sound ☐ Cracked ☐ Leaks

Frame View

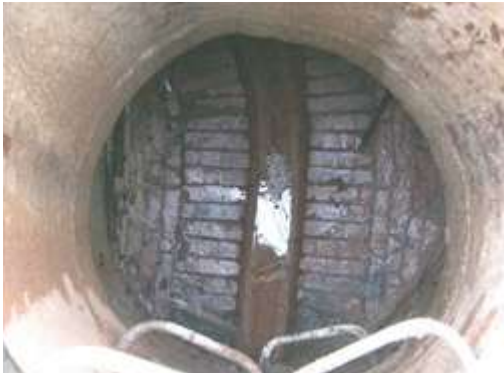
Defect 2

Count: **5** Missing: **0** ☒ **Corroded**

corroded steps

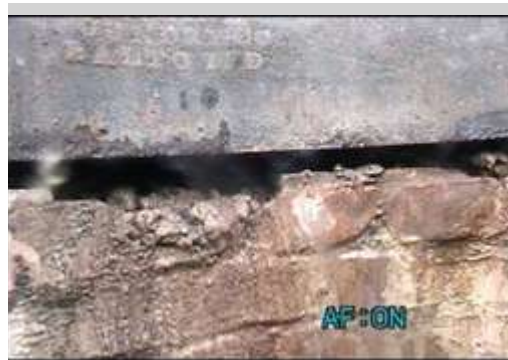
Defect 3

Condition: ☐ Sound ☐ Cracked ☐ Root Intrusion ☐ Loose Brick ☒ **Deteriorated**

Infiltration: ☐ None ☒ **Joint** ☐ Cracks ☐ Mortar ☐ Roots ☐ Wall

infiltration at deteriorated corbel-frame joint (no chimney)

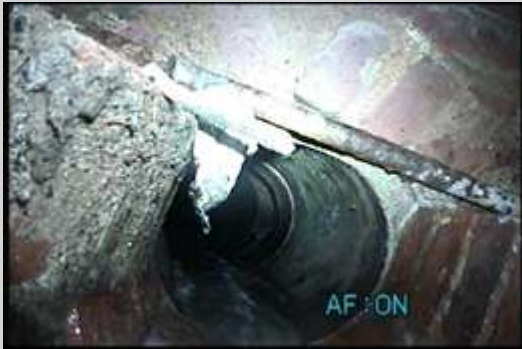
12 O'Clock Outflow

8 in. Circular Gravity Sewer  
Pipe Out @ 12 O'Clock

Infiltration: **None** Pipe Seal Cond: **Sound**

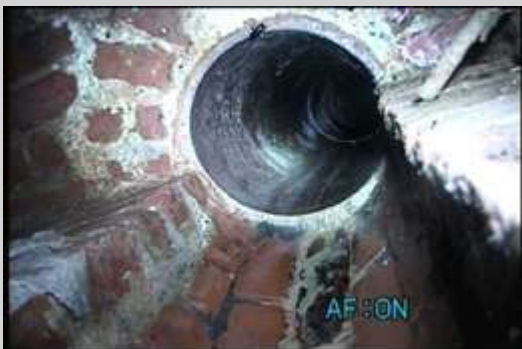
6 O'Clock Inflow

8 in. Circular Gravity Sewer  
Pipe In @ 6 O'Clock

Infiltration: **None** Pipe Seal Cond: **Sound**

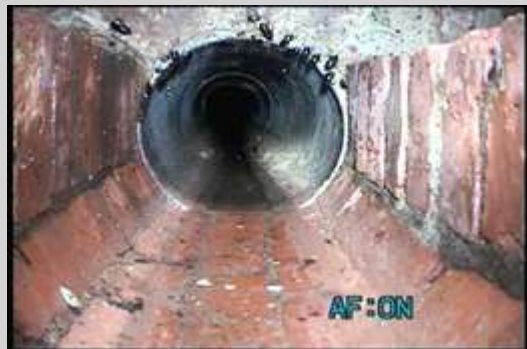
9 O'Clock Inflow

Pipe In @ 9 O'Clock

Infiltration: **None** Pipe Seal Cond: **Sound**
